AIMS

The AIMS service

Overview through images

The **Asset Impact Monitoring from Space (AIMS)** is a high-tech, data-driven, service that uses satellite imagery and landscape monitoring techniques to demonstrate and evaluate the impact of asset creation and livelihood programmes. Launched as pilot project in 2017, it has experienced tremendous growth ever since and it is now a full-fledged service that has so far benefited **24 countries** from **6 Regional Bureaux**. The service is run by the Climate and Earth Observation (CIEO) unit of the Research, Assessment and Monitoring (RAM) division together with the Asset Creation, Livelihoods and Resilience (PROR-L) unit of the Programme division and its outcomes now represent one of the pillars of future evidence-based programming decisions.

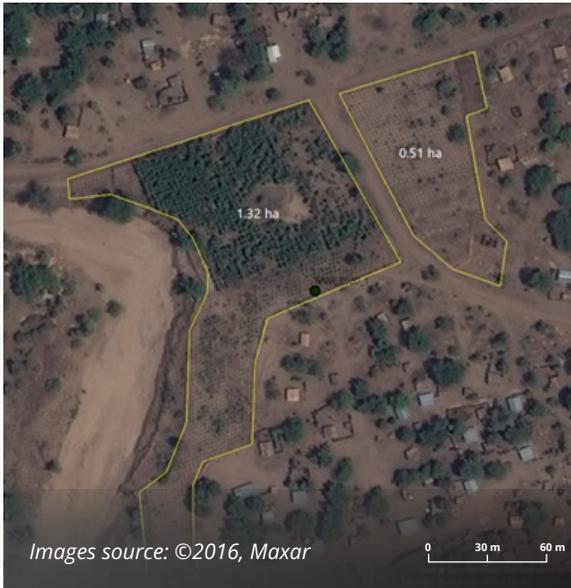
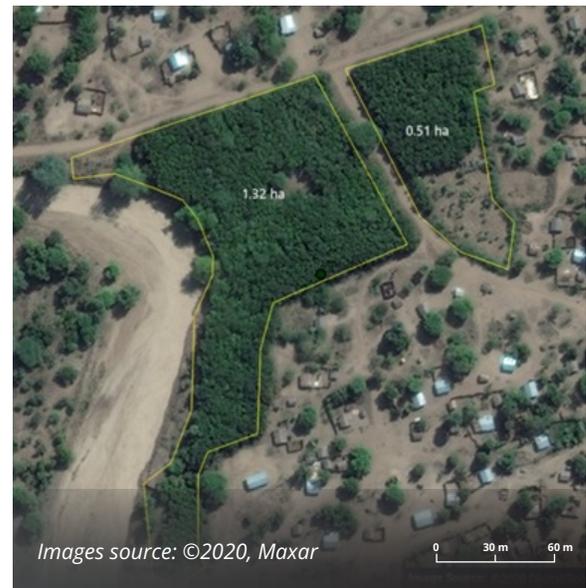
Fig. A - BEFORE intervention - November 2016

Fig B. - AFTER intervention - August 2020

OUTCOMES - The decrease in soil erosion and the availability of timber and fuelwood are clear indicators of the successful implementation of the asset, as evidenced by the expansion of the woodlot area in the after scene.

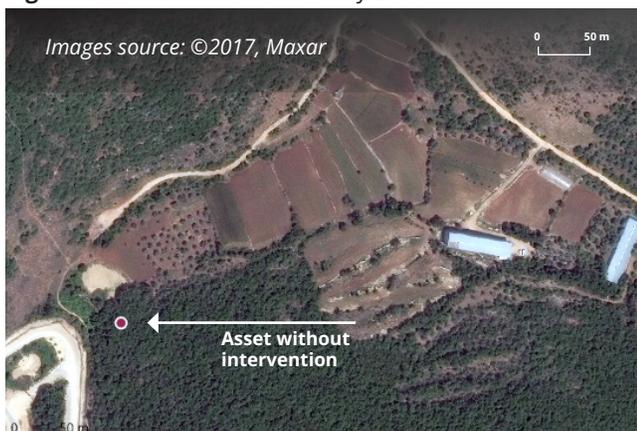
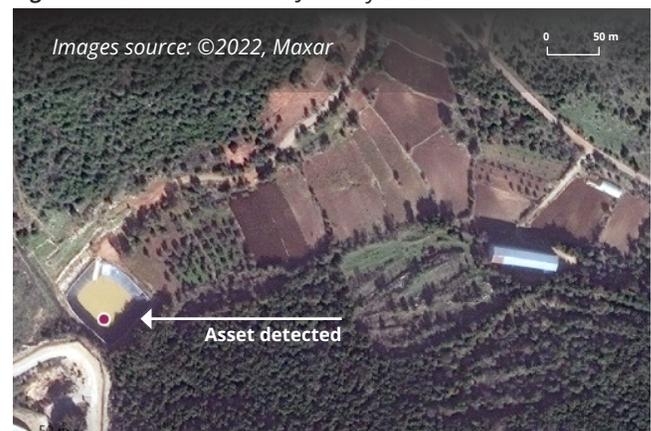
Fig. C - BEFORE intervention - May 2017

Fig. D - AFTER intervention - January 2022

OUTCOMES - The project aimed at rehabilitating an agricultural pond with a capacity of 7,500 cubic meters to ensure access to irrigation water. With an impact of over 90 ha of agricultural lands, the project benefits the population of Aita el Shaab Community. In fig. C, there is evidence of a degraded pond, while in fig. D, we can see that the asset has been deepened and rehabilitated, thereby confirming successful project implementation.

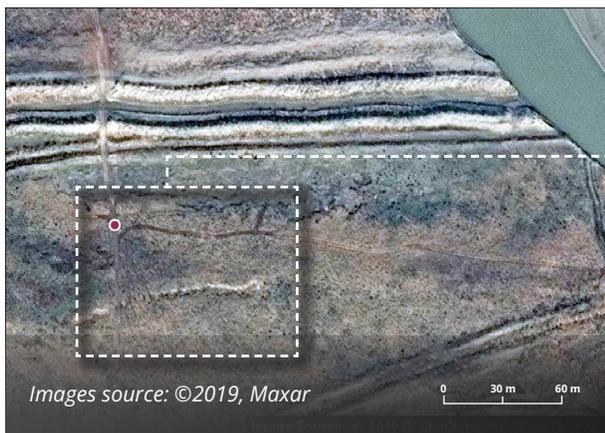
Fig. E - BEFORE Intervention - Jan 2019

The image from 2019 (Fig. E) shows a land with some irrigation channels and little agricultural activity. In 2021 (Fig. F) the presence of the gridded features across the intervention area and the solar panels confirm that the project was successfully implemented.

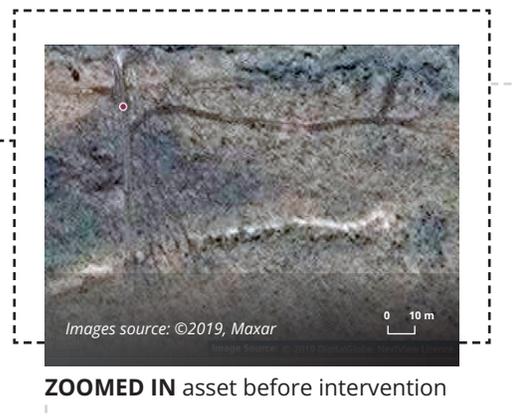
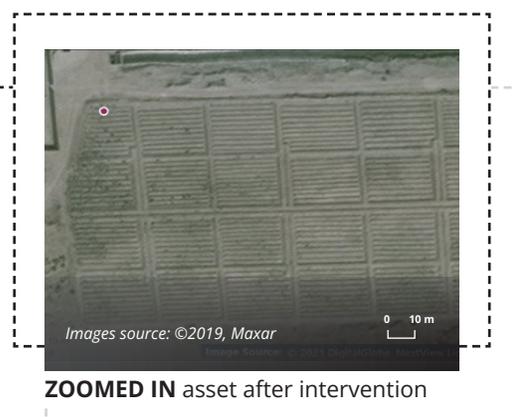
Fig. F - AFTER Intervention - Sep 2021

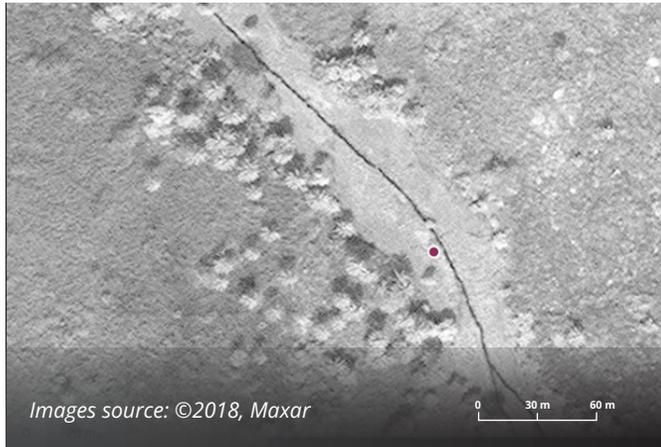
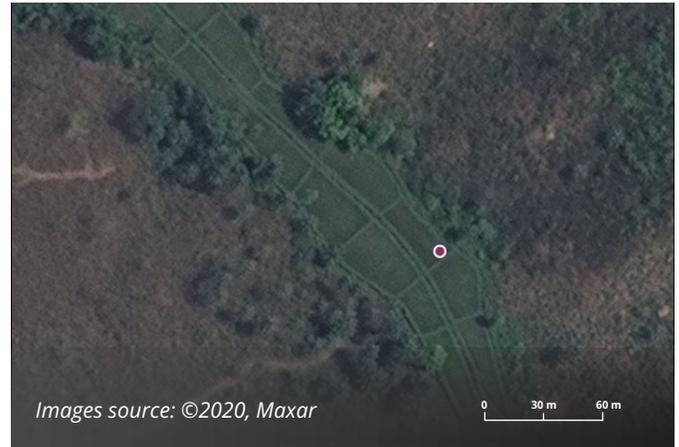
Fig. G - BEFORE Intervention - January 2018

Fig. H - AFTER Intervention - February 2020

Fig. G and Fig. H depict the before and after stages of the implementation of an inland valley swap – it is clearly possible to identify the linear physical grid structures and the central water channel in the 2020 satellite imagery.

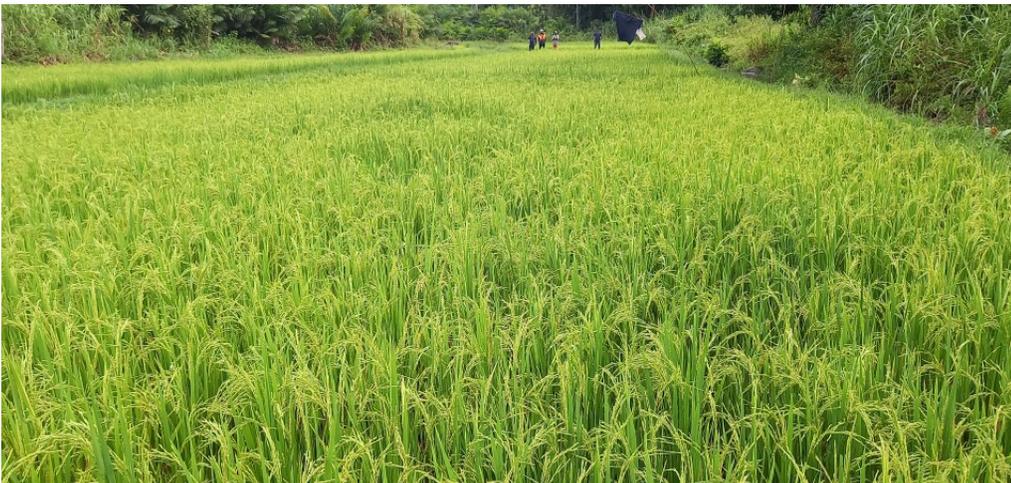
Inland valley swamp at ground level. *Image source:* WFP Sierra Leone Country Office, 2021

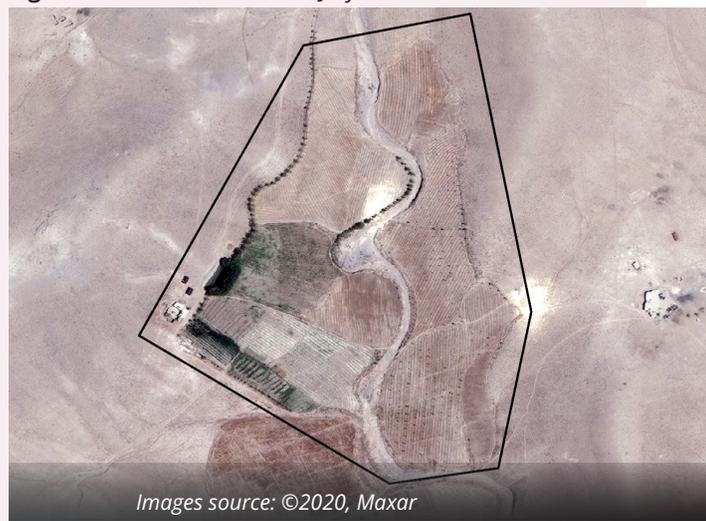
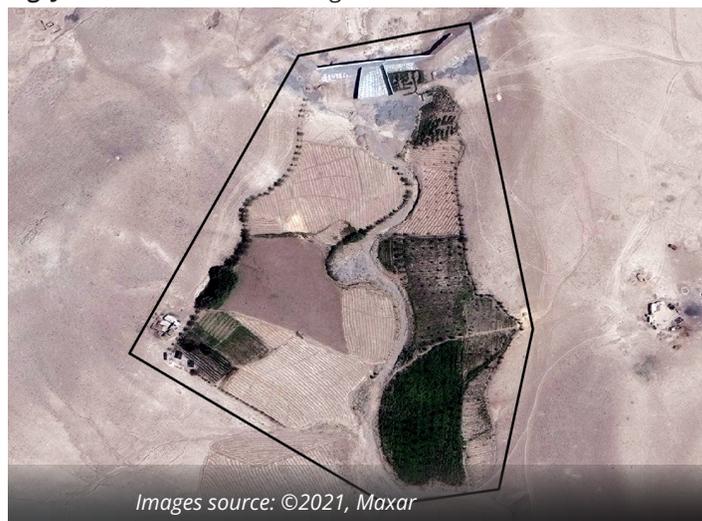
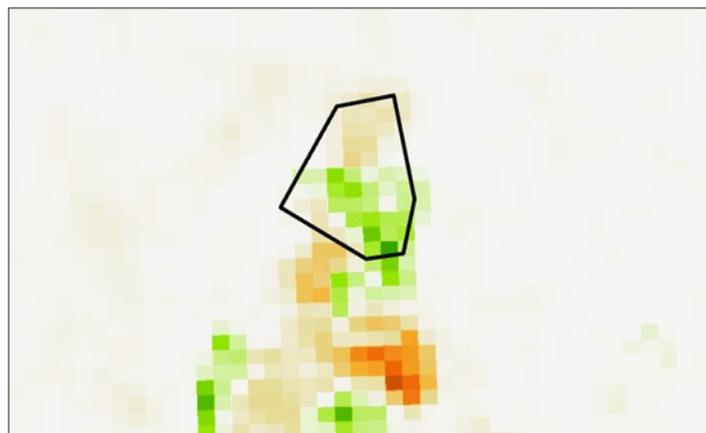
Fig. I - BEFORE intervention - July 2020

Fig. J - AFTER intervention - August 2021

NDVI difference between 2019 and 2022 (Jun-Sep)

The development of the asset site (5 ha) can be seen by looking at the 2020 and 2022 images. By comparing satellite images of the same location taken during the dry seasons of 2013 (pre-intervention) and 2022 (post-intervention), it is possible to identify areas where vegetation has improved (shown in green) and areas that have deteriorated (shown in red). Within the site, a significant increase in vegetation conditions was observed extending to approx. 1.5 ha. This indicates that the project has had a positive impact on the health of the vegetation in the area.

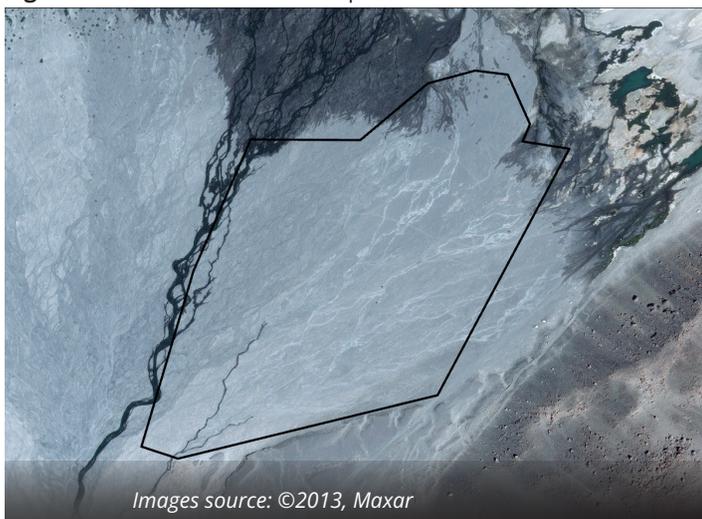
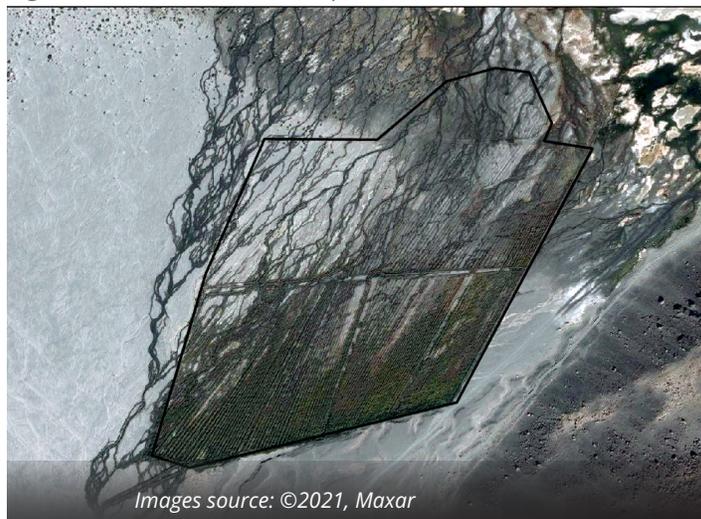
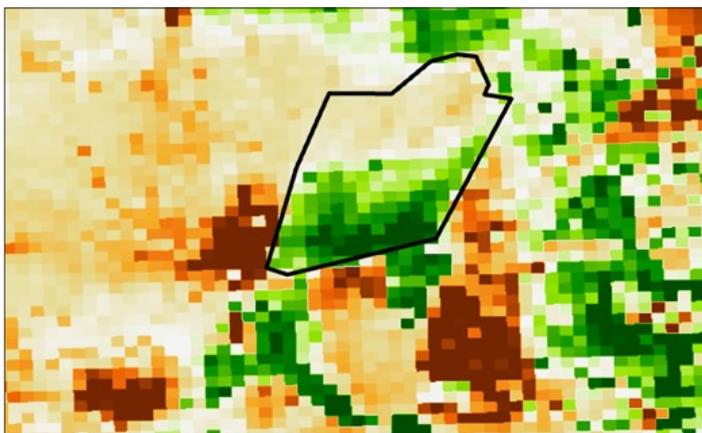
Fig. K - BEFORE intervention - September 2013

Fig. L - AFTER intervention - September 2021

NDVI difference between 2013 and 2021 (Jun-Sep)

The satellite imagery comparison between the dry seasons of 2013 (pre-intervention) and 2021 (post-intervention) allows us to assess changes in vegetation health at the project site. The difference in vegetation greenness provides a clearer view of the areas presenting improved vegetation conditions (green) and areas that have been degraded (red). The project site experienced an increase in vegetation cover, extending to approx. 7.3 ha, out of a total site area of 20 hectares. This indicates that the intervention has had a positive impact on the greenness and overall health of the vegetation in the project area.

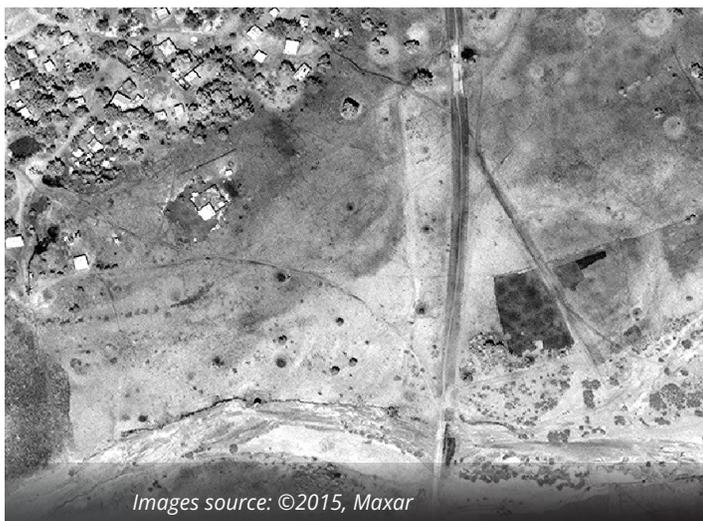
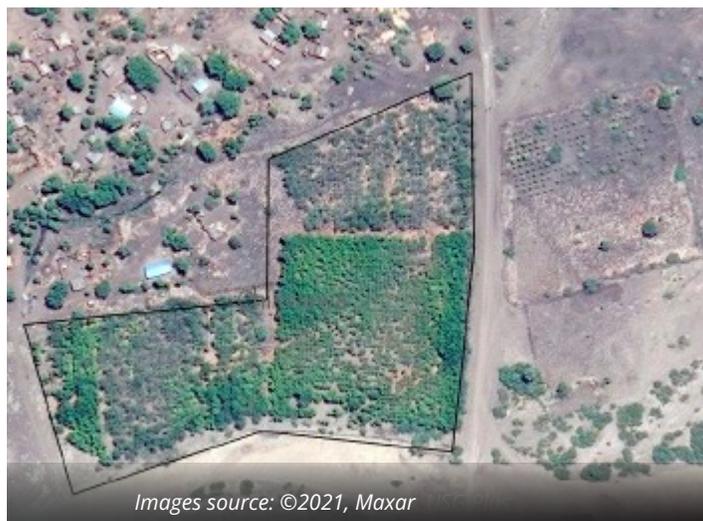
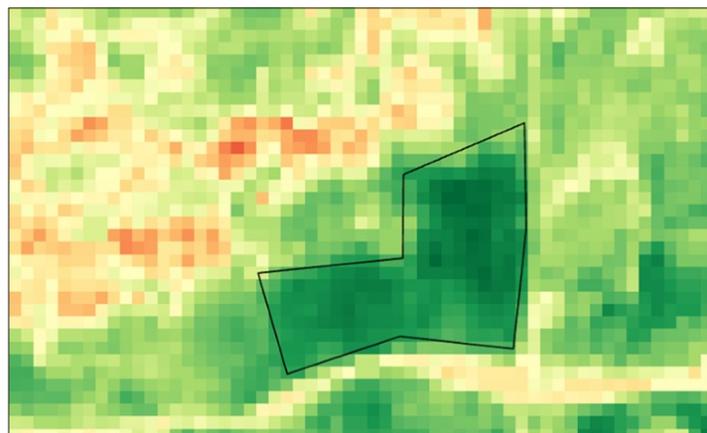
Fig. M - BEFORE intervention - December 2015

Fig. N - AFTER intervention - October 2021

The images show the change of vegetation conditions between the wet seasons in 2015 and 2019. Green indicates an improvement of the vegetation conditions, meanwhile red indicates a deterioration of the vegetative cover. Within the project area, a strong improvement of +0.9 can be identified. This demonstrates the success of the reforestation activities, as the implementation area shows stronger greening compared to the surrounding landscape.

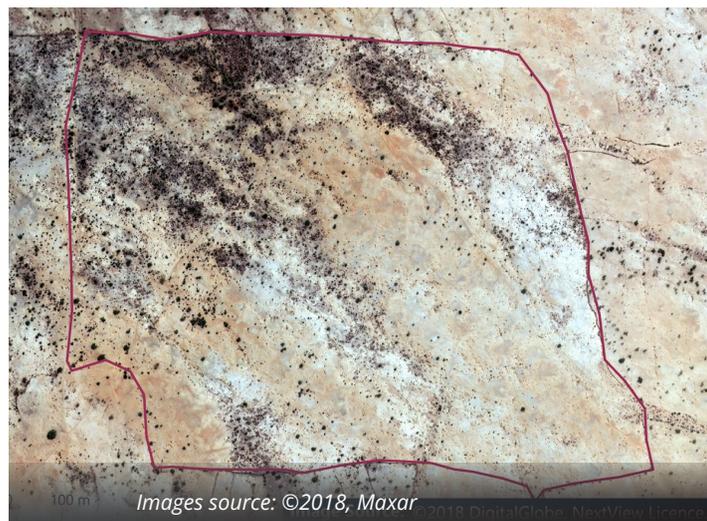
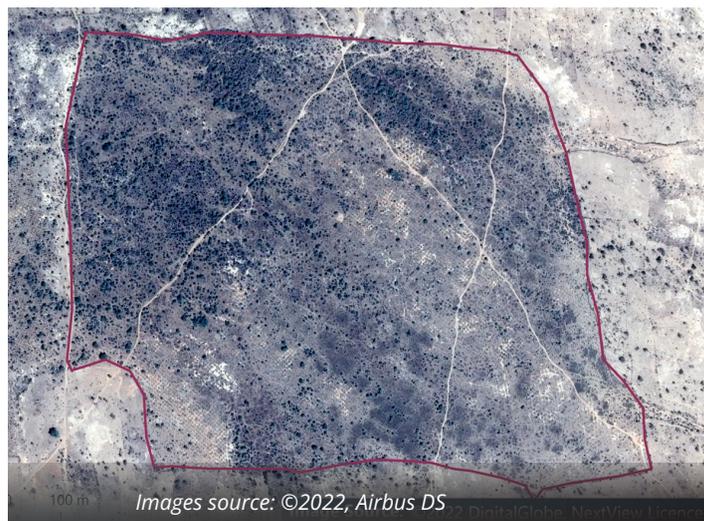
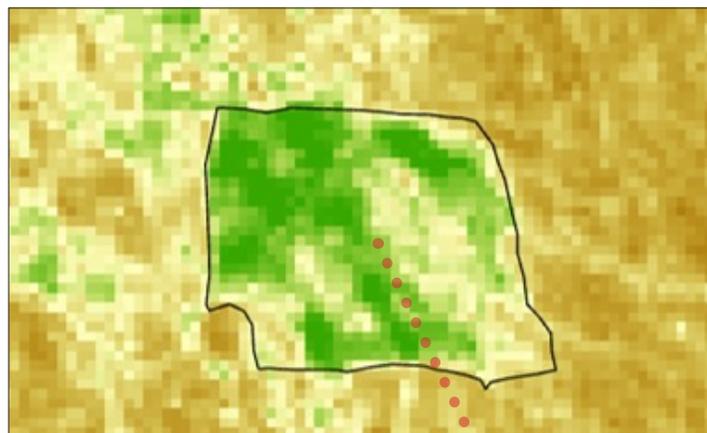
Fig. O - BEFORE intervention - June 2018

Fig. P - AFTER intervention - February 2022

Vegetation conditions during rainy season 2021

The intervention site showed vegetation greenness values higher than 0.5 on an area of approximately 4.5 ha in 2018, which expanded to 16 ha in 2021. This robust improvement in vegetation health conditions over several years, despite changing rainfall patterns, confirms the successful implementation of the intervention and its potential for long-term positive impact.

As shown in the vegetation greenness analysis covering the July-September 2021 rainy season, vegetation conditions substantially improved within the project site following the intervention. The vegetation showed a robust response to changing rainfall conditions at the site, while the surrounding area had less vegetation cover.
